REHOBOTH FIRE DEPARTMENT HEADQUARTERS SECTION &
COMPANY 1 QUARTERS - PUBLIC SAFETY BUILDING

OVERVIEW

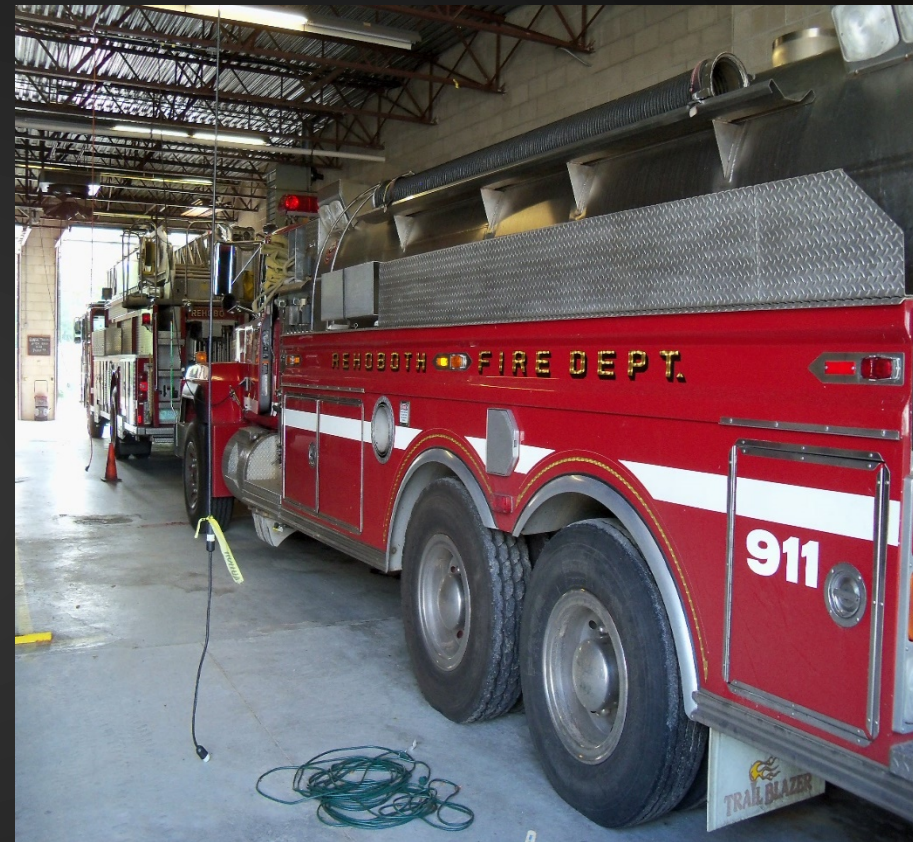
- ▶ Over the course of the last twenty-two years all of the apparatus that was housed when the building was opened has been replaced with much larger and more sophisticated trucks and equipment. Tanker 1 has to be driven out the front door of the station as there is not enough room in the rear of the property to back the truck in safely or for it to make the turn out of the bay to get to Anawan Street. In cases where only the tanker is needed, Ladder 1 has to be pulled out of the way delaying response.

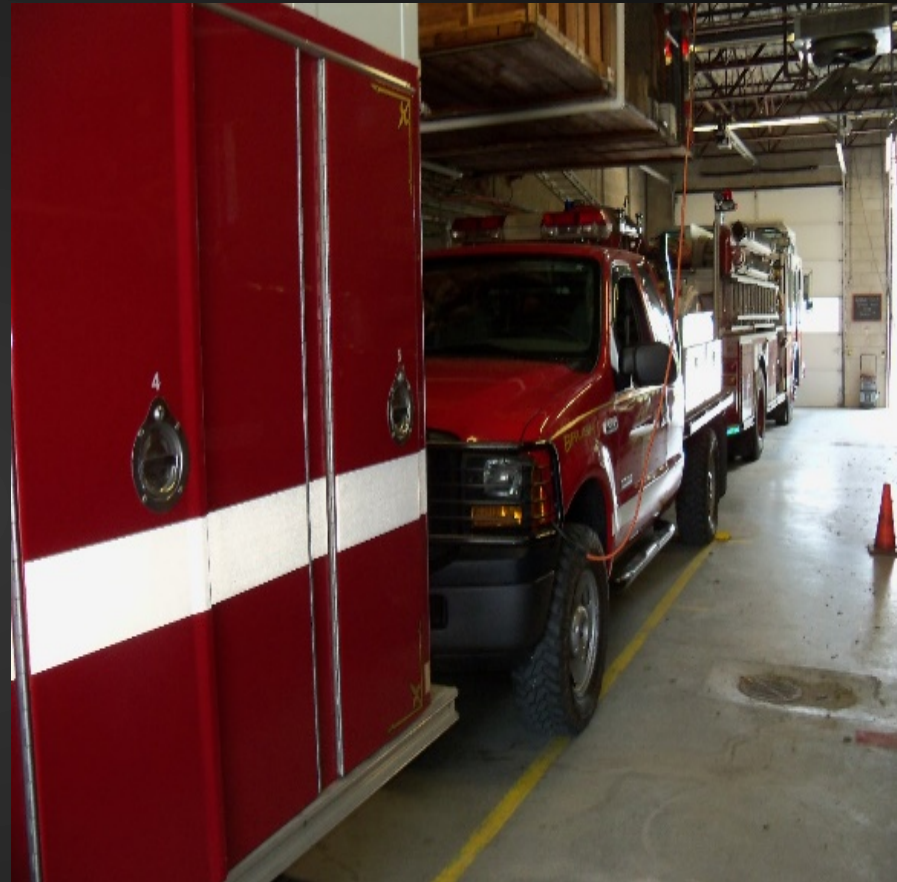
- ▶ The same situation exists with Brush #1. When a call for a brush fire is received Special Hazards or Engine #1 has to be moved to get the truck out of the station.

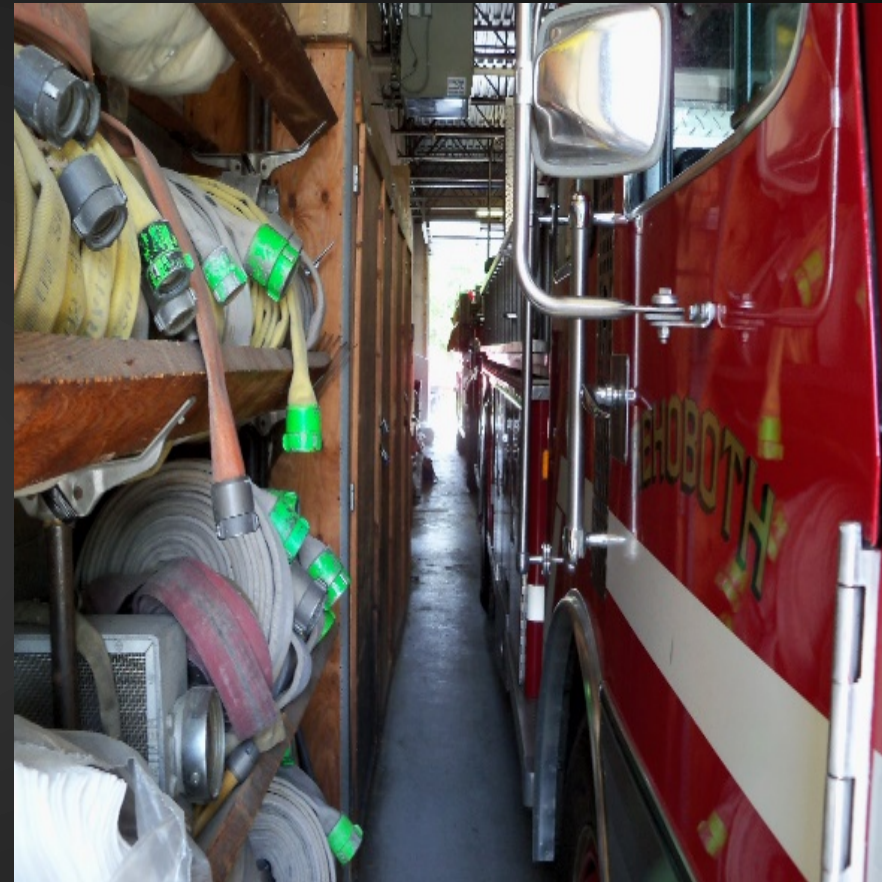
- ▶ When apparatus is parked in the building, access to hose, supplies and storage is impossible. Trucks have to be constantly moved to access these areas throughout the station. This means apparatus has to be put outside in extreme weather conditions so mission critical duties and readiness procedures can be performed. In cold weather trucks need to be kept running so water tanks and pumps don't freeze.

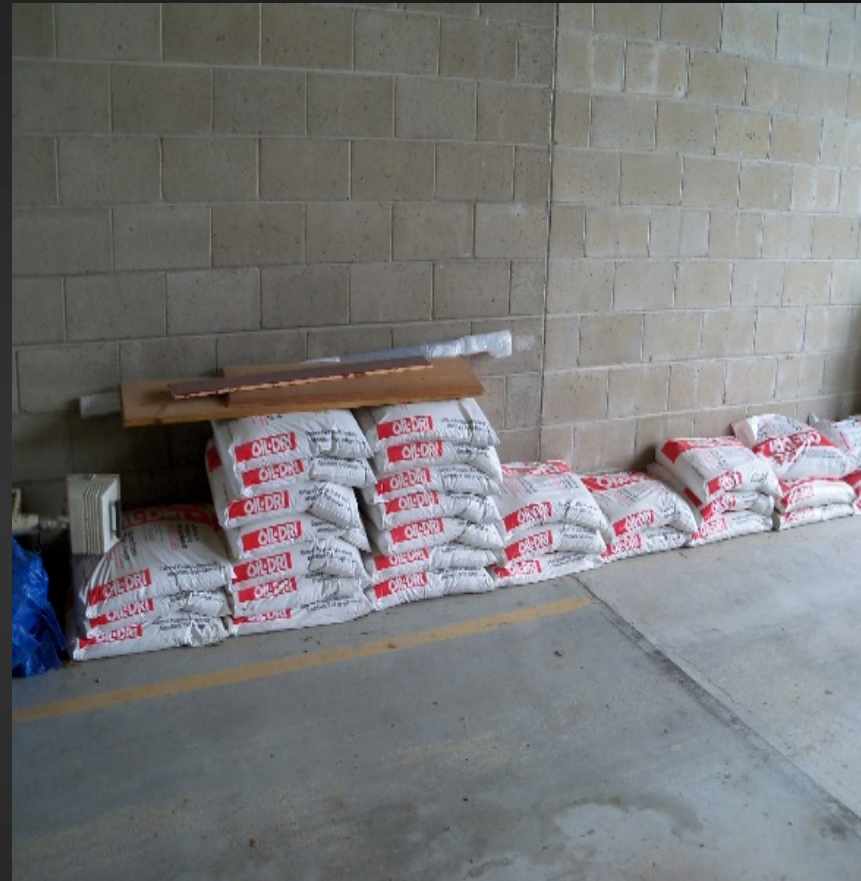
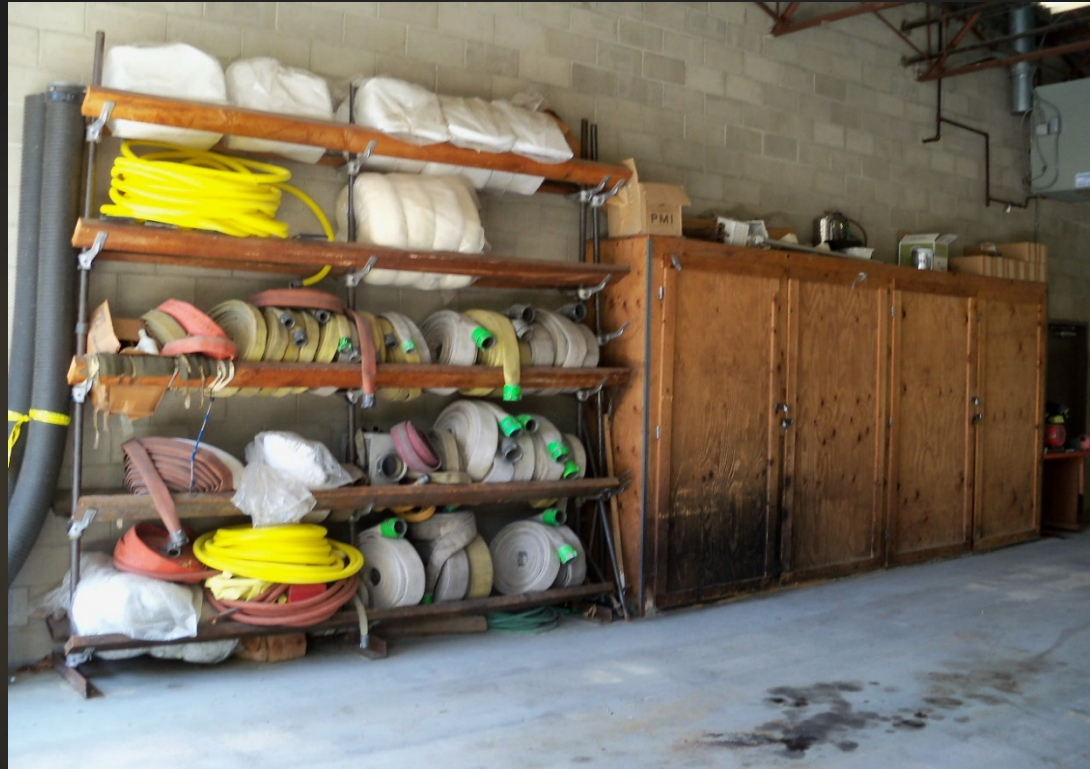
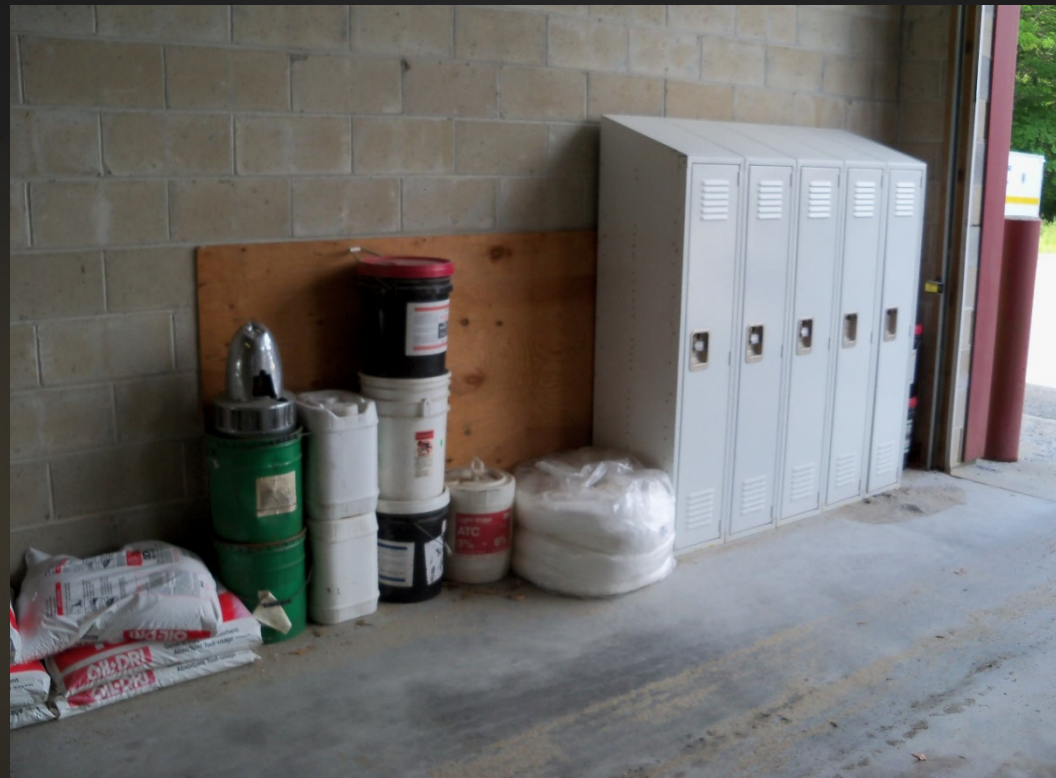
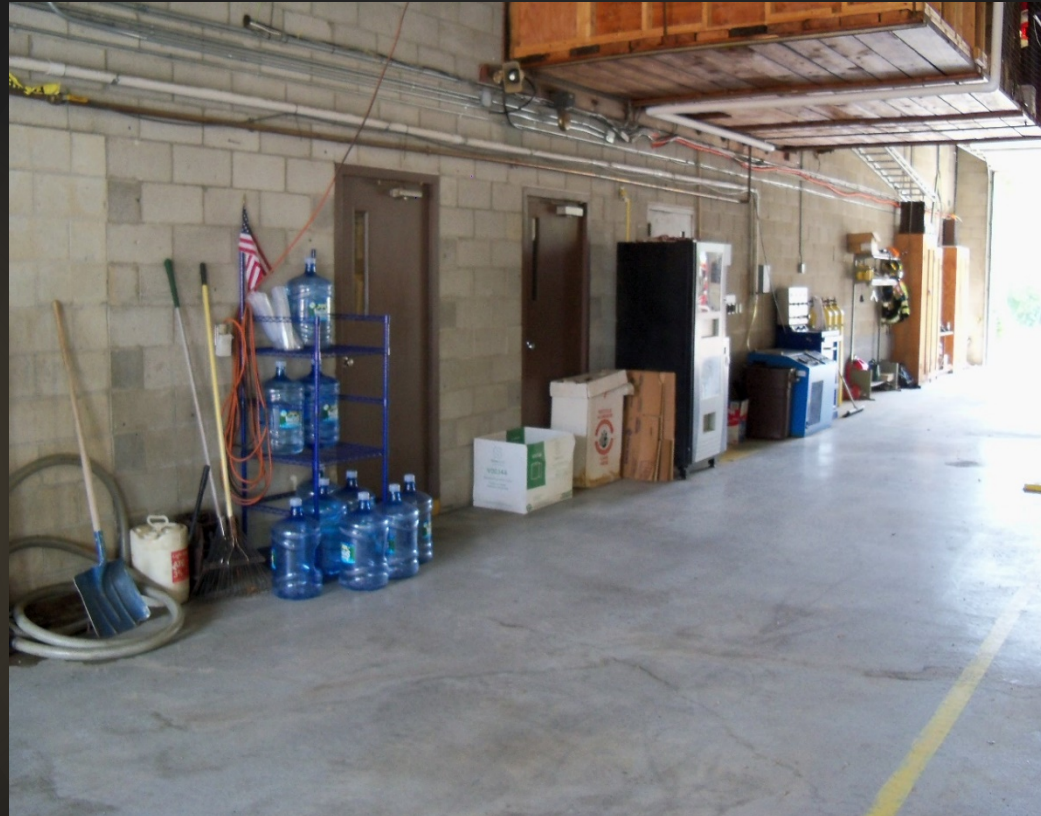
- ▶ Everything from fluid absorbents, foam, spare bottles etc. has to be stored around the perimeter of the apparatus floor. Tripping hazards abound.

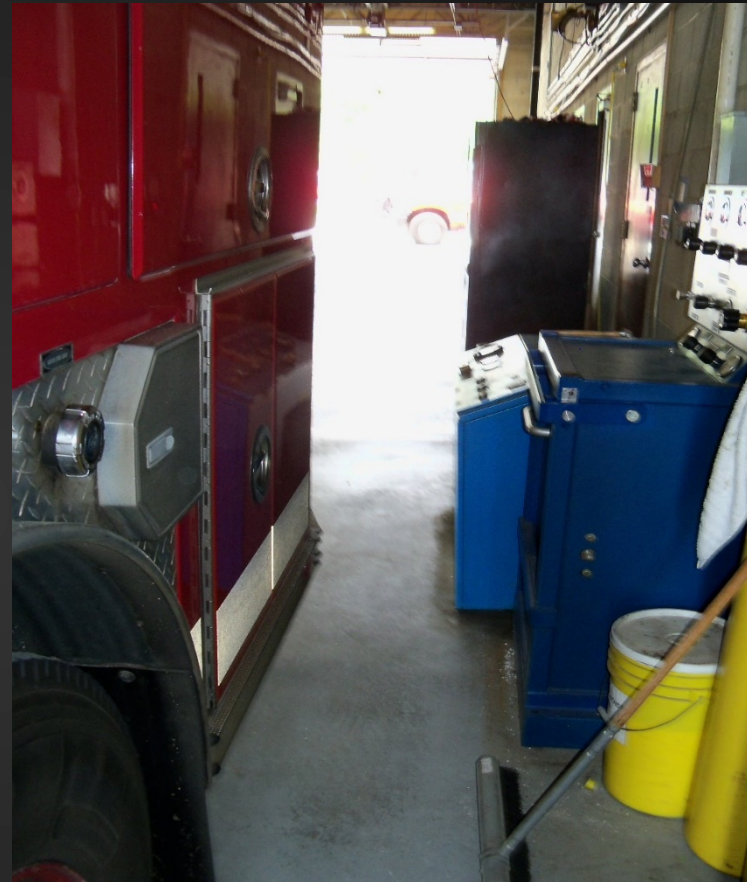
- ▶ The self contained breathing apparatus bottle filling station cannot be accessed or used when the trucks are in quarters.

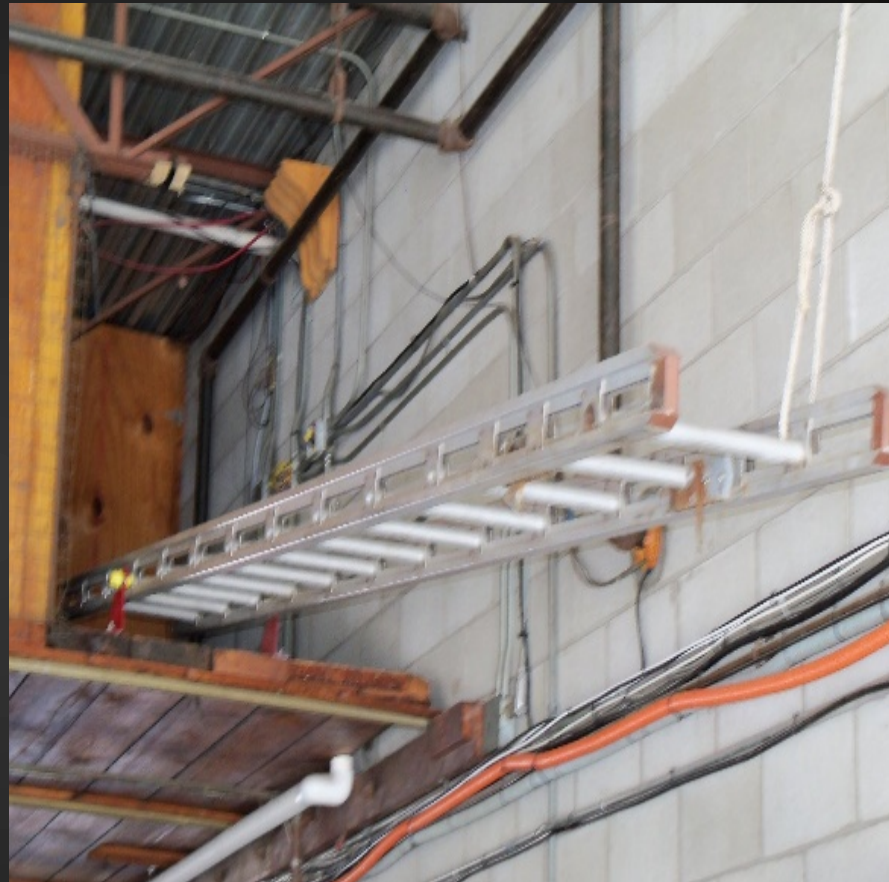
- ▶ Access to the overhead storage area and radio equipment room is over an old fire ladder that hangs from the ceiling by a rope. Hardly OSHA compliant.

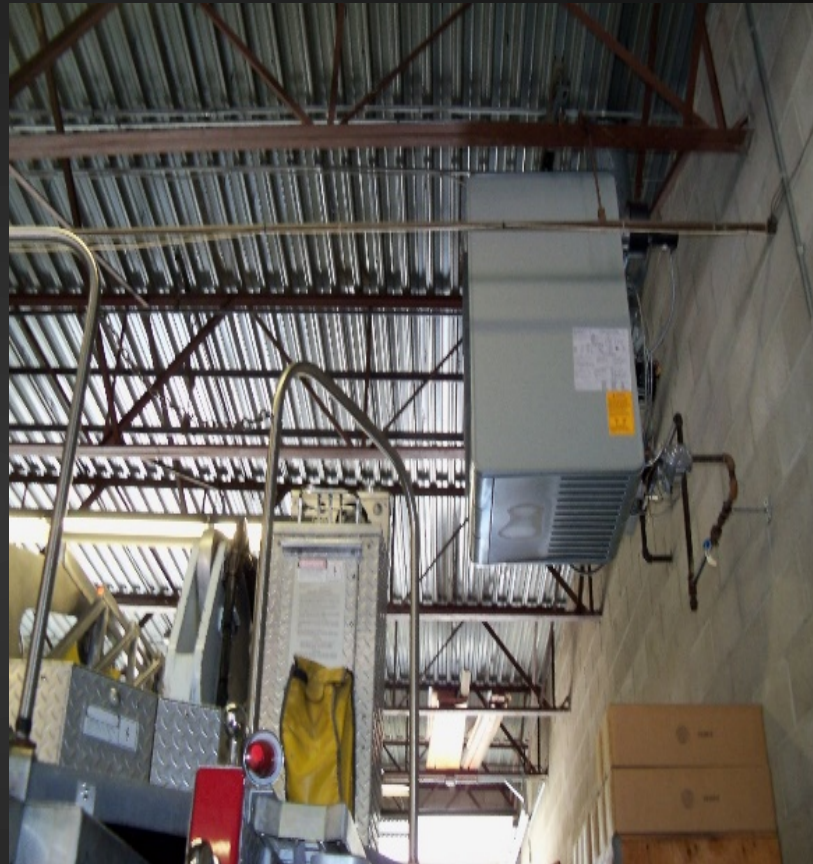
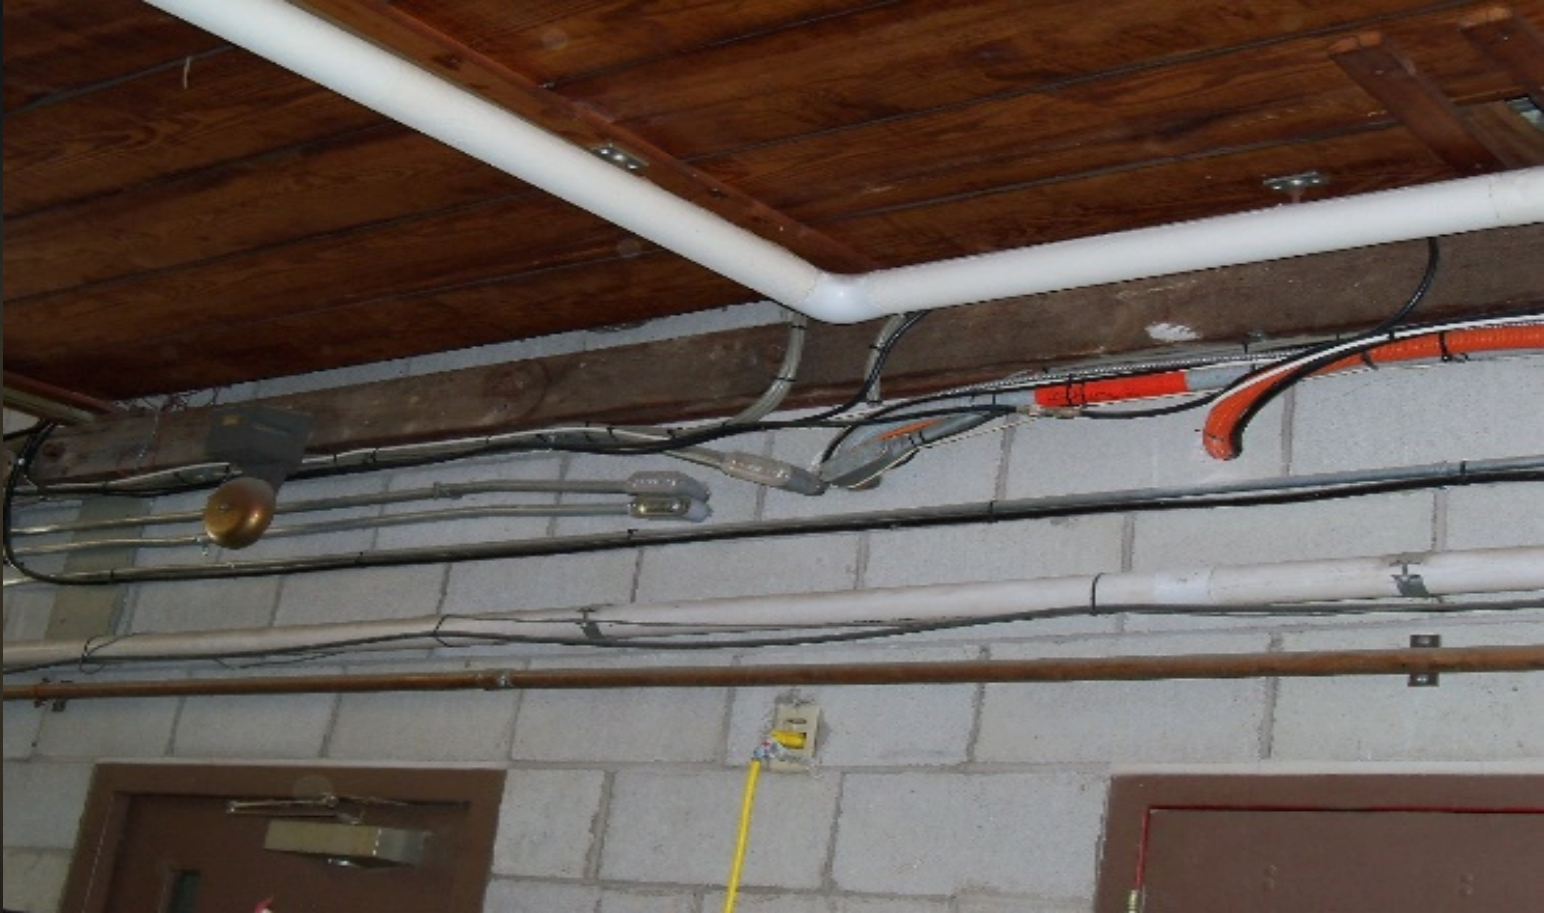
Utilities

- ▶ There is a myriad of gas pipes, electrical conduits, plumbing computer and phone cables that have been introduced over the years. Care has to be used when moving trucks or doing just about anything else in the apparatus bay to avoid damaging this infrastructure.

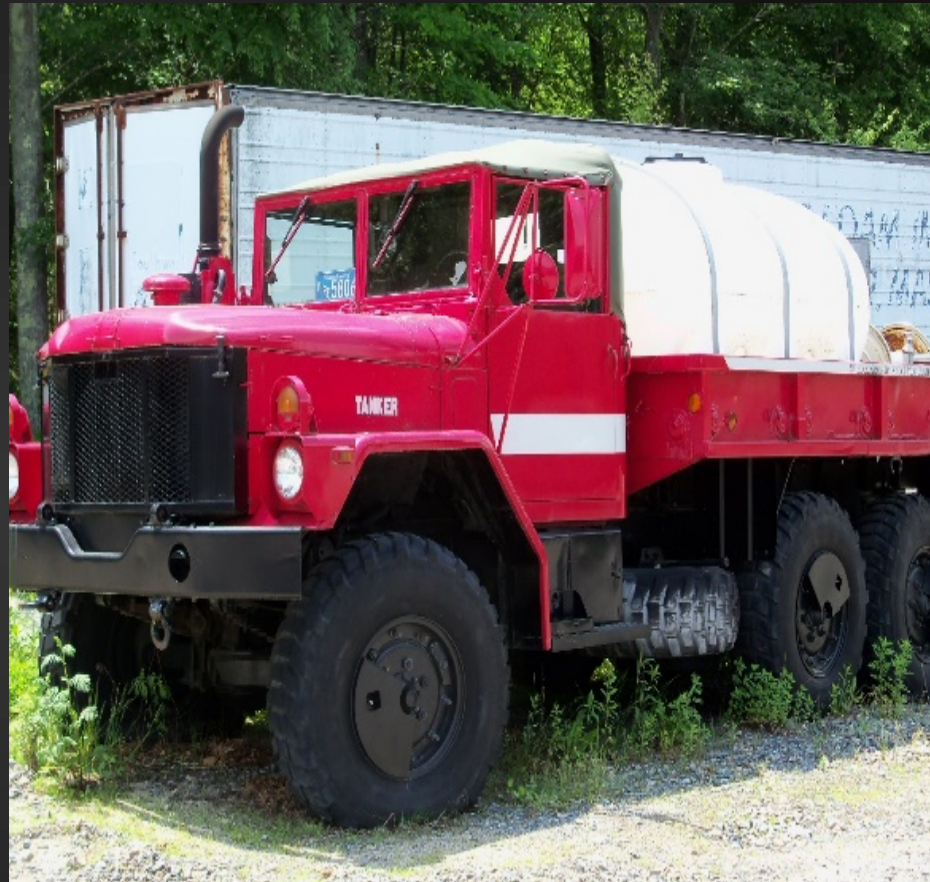
- ▶ Forestry 1 is kept outside year round. It has to be drained and taken completely out of service in the Fall and put back in service in the Spring. The weather wreaks havoc with the truck and leads to unnecessary maintenance issues and costs.

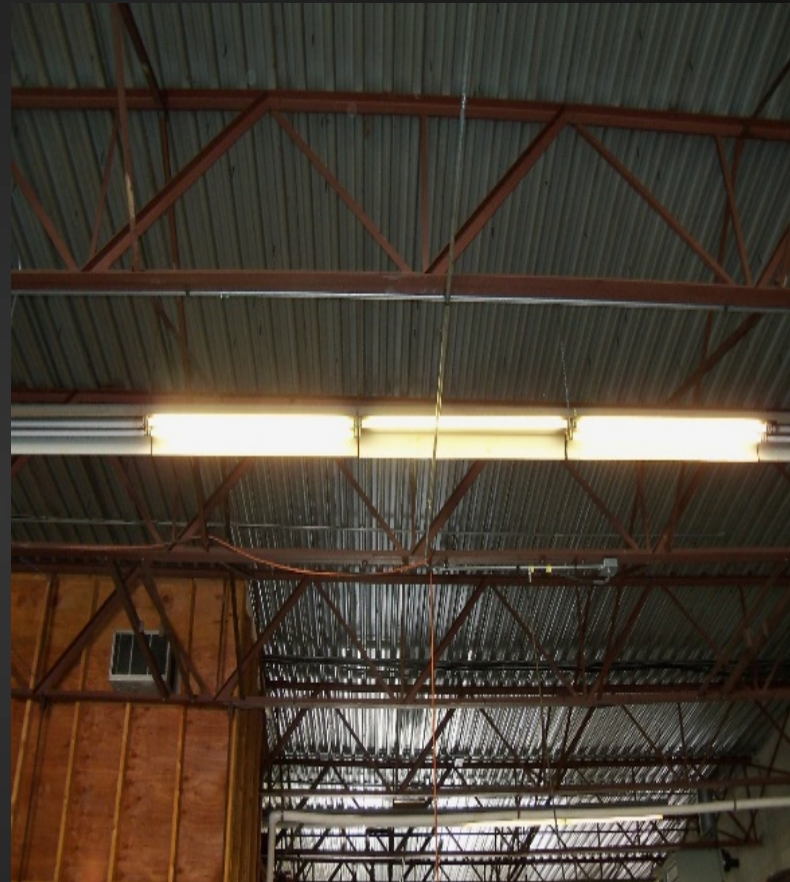
Lighting

- ▶ To say the lighting in the apparatus bay is poor would be a compliment. You cannot check fluids in apparatus, read gauges, do any type of minor repair or read directions without a flashlight. This type of lighting also wastes copious amounts of energy.

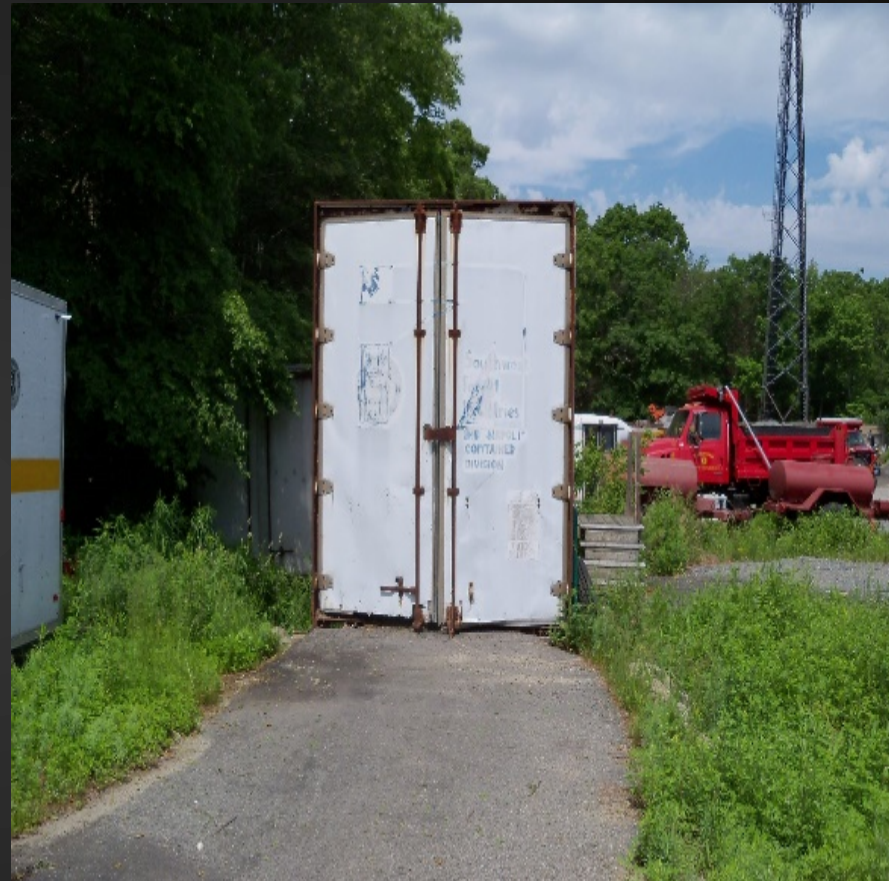
Other storage

- ▶ The Department also incorporates the use of two old storage trailers to keep surplus equipment, tables and chairs for training and events and supplies. These trailers constantly develop leaks, are loaded with bees in the summer and are occupied by various rodents and birds.

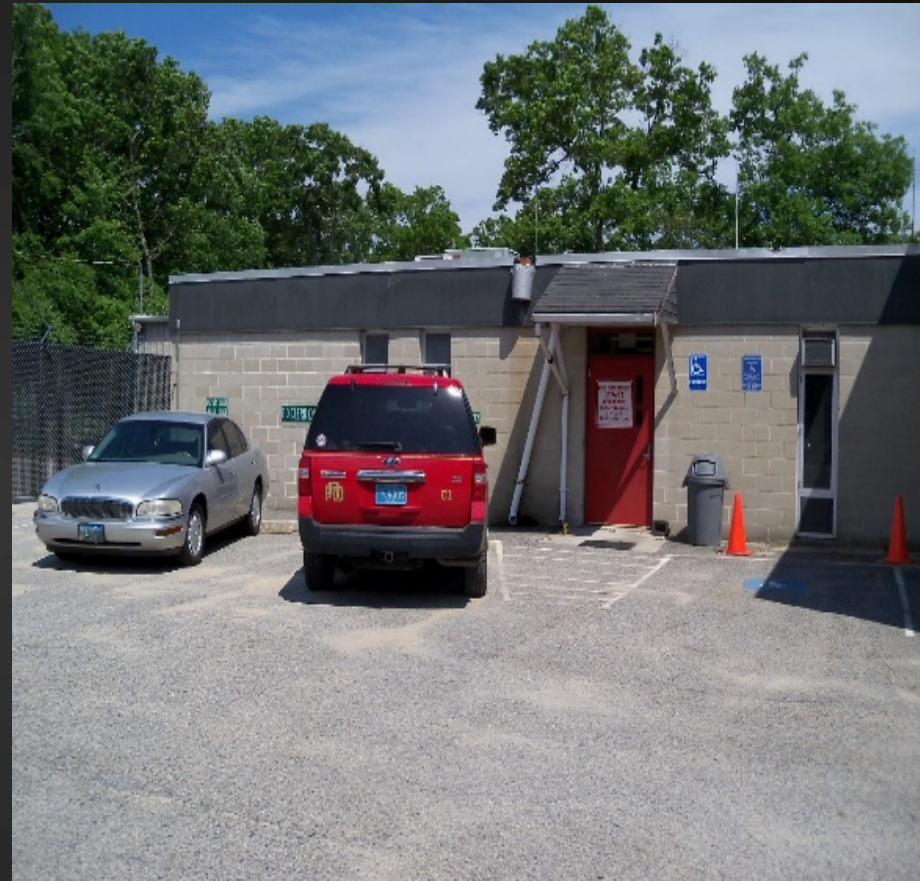
FD Entrance

- ▶ This is the entrance to Fire Department Headquarters. It leaves little to be desired aesthetically. The entrance is located in the rear of the building and most people who come for the first time have trouble locating it. The access road is located 100 feet North of the East facing bays doors and is one way. There have been instances where customers have parked in front of the apparatus bay doors blocking them from response. People also arrive and leave in the wrong direction. There have been near miss collisions with other customers and fire apparatus.

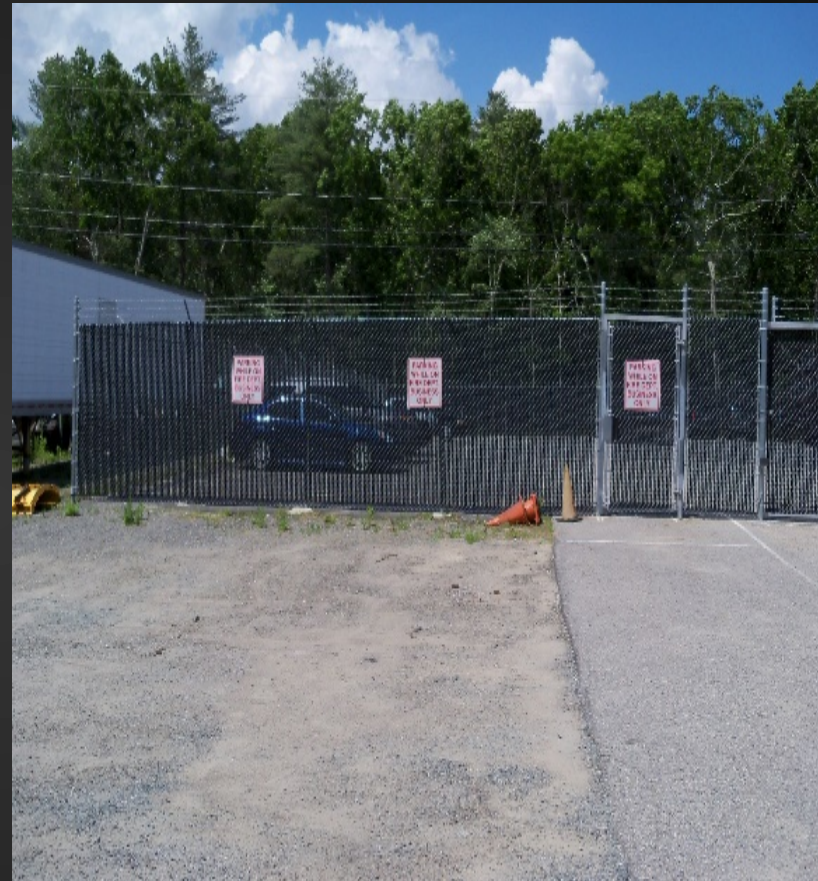
Parking

- ▶ Customer parking consists of three spaces. One is partially on the pavement and the other two are in the dirt. When it rains the area gets muddy and when it snows the area is difficult to clear. The Department receives numerous complaints from customers about this area. Elderly and mobile impaired customers who cannot use the one handicapped space have a hard time negotiating this area.

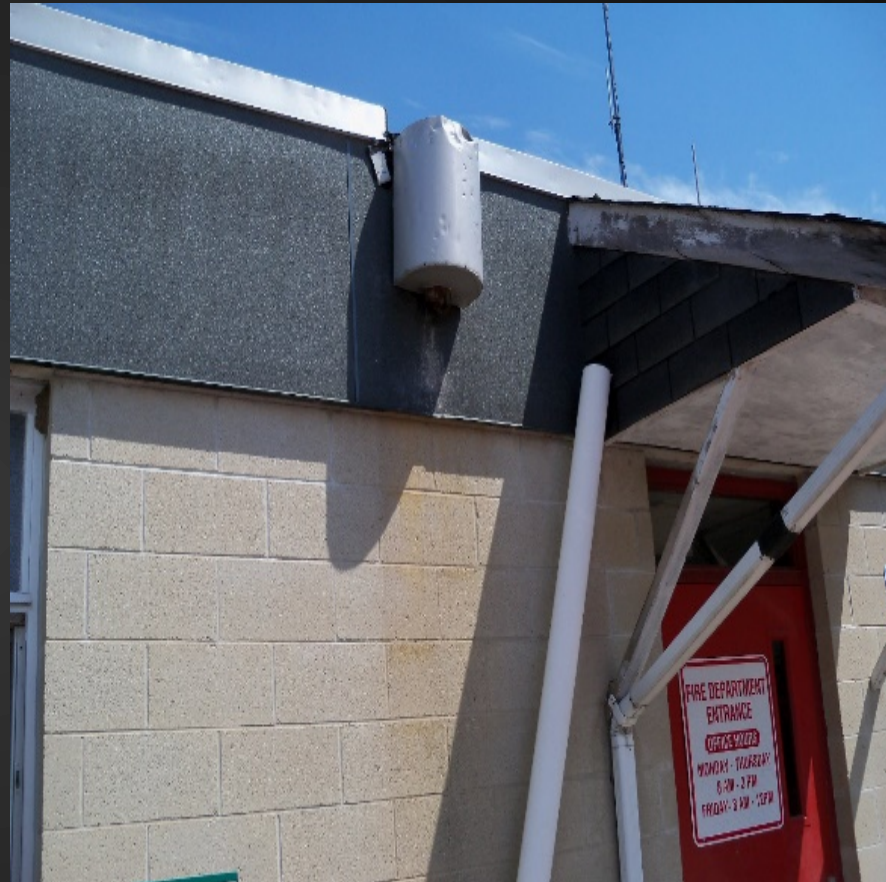
Roof drain

- ▶ The roof drain off of the rear of the building has been an issue for numerous years. Due to poor original design, the drain has frozen and thawed so many times it is all but impossible to keep it together. When it freezes it pushes the drain pipe off of the building. In warmer weather heavy rain has the same effect. There is constantly water running by the entrance to the station for 2-3 days after a storm. The entrance is always icing over and needs to be treated several times a day to prevent slips and falls. Even if the water is directed away from the entrance due to the grade of the area it runs right back.

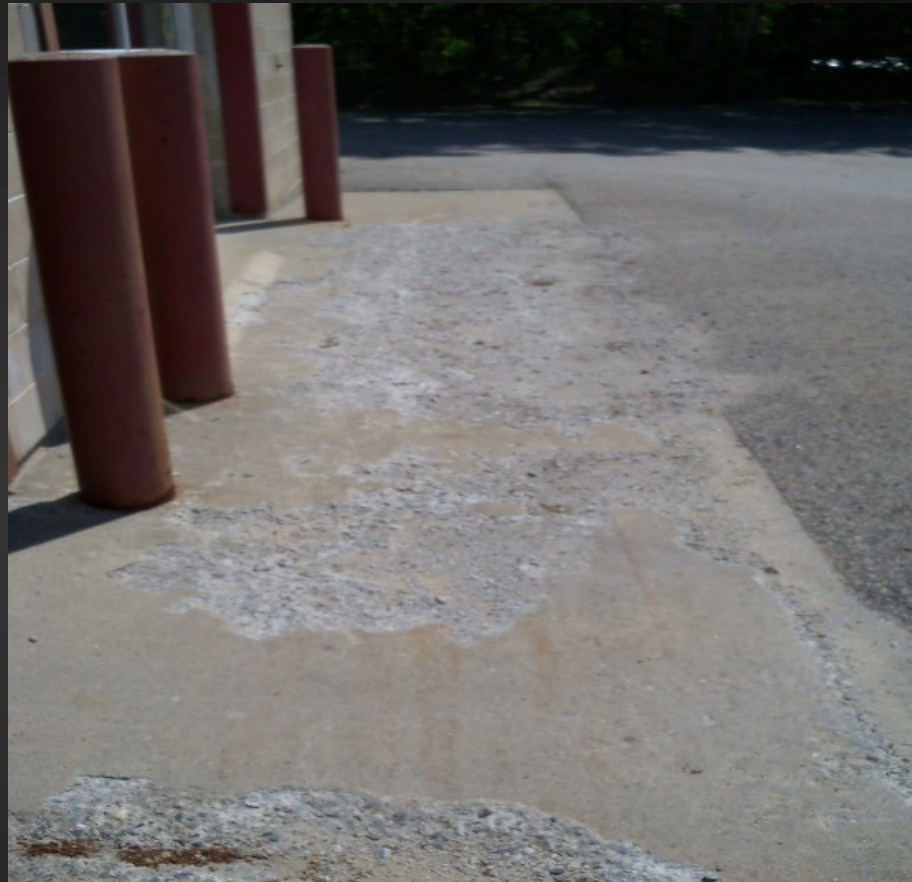
Aprons

- ▶ The concrete aprons at the rear bay doors have been deteriorating for years. They have been patched over and over but continue to erode. This leads to drainage and icing issues.

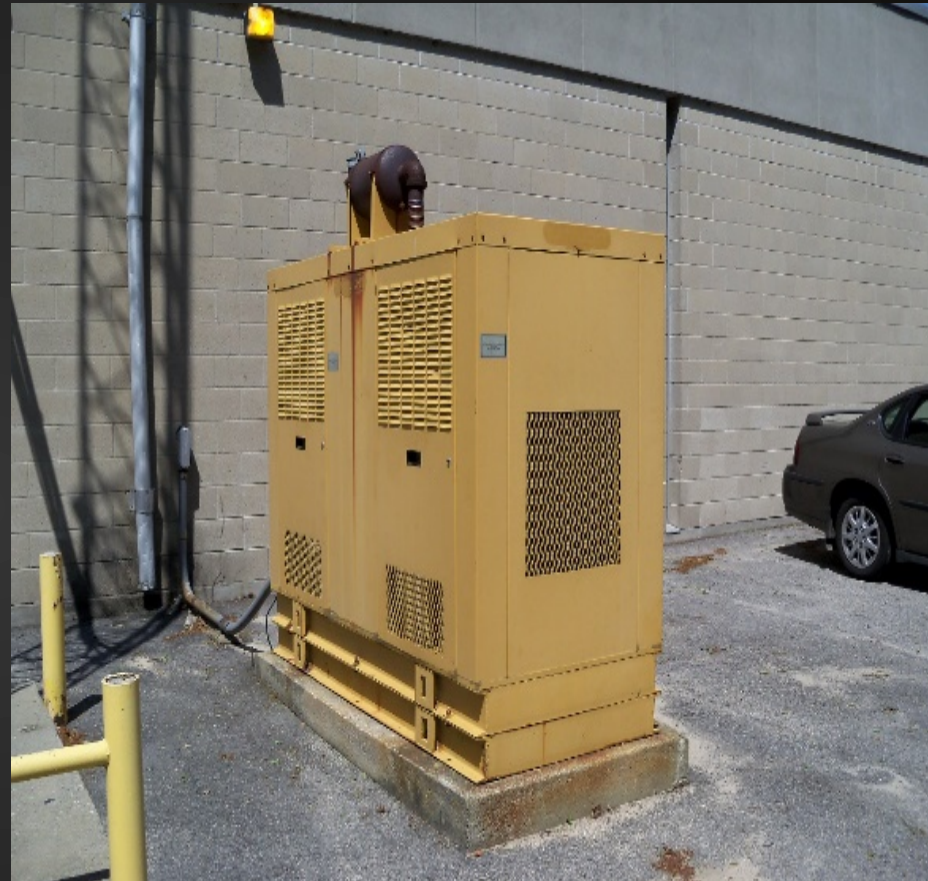
Generator

- ▶ The emergency generator for the building was evaluated last year and has reached its full capacity. We are in danger of total power loss if it was to fail. It also only has a twenty gallon fuel tank. When there is an extended loss of power, it has to be constantly monitored and diesel fuel has to be trucked to it from the Highway Garage.

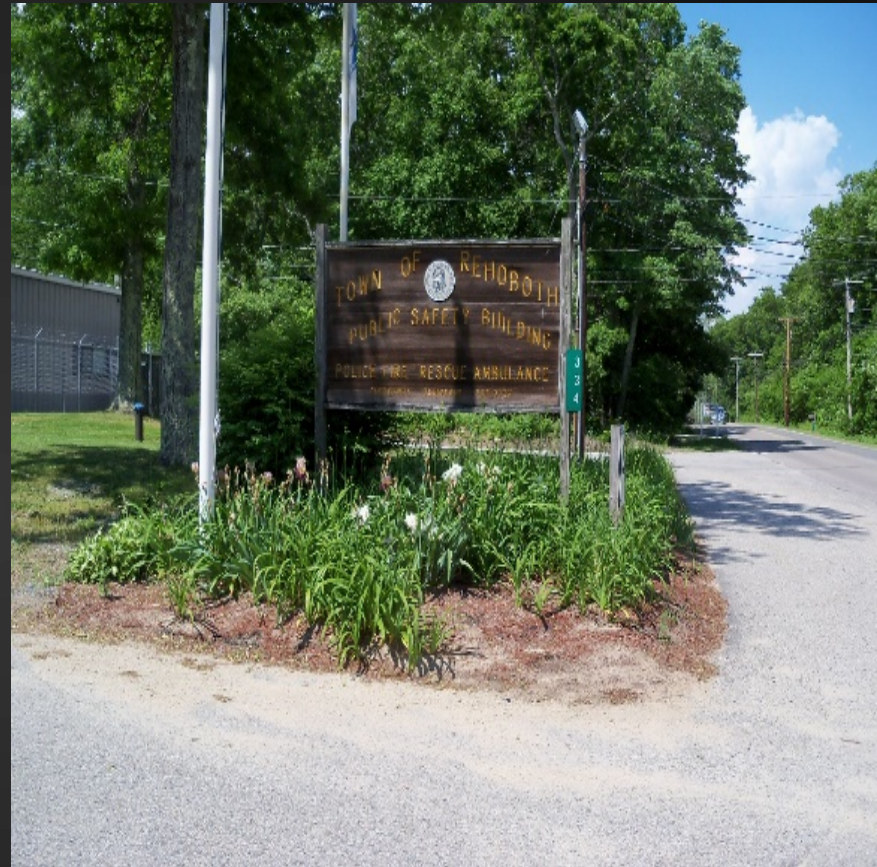
Signage

- ▶ The signage and identity of the building are poor. This leads to more confusion when people or deliveries are trying to locate the Department.

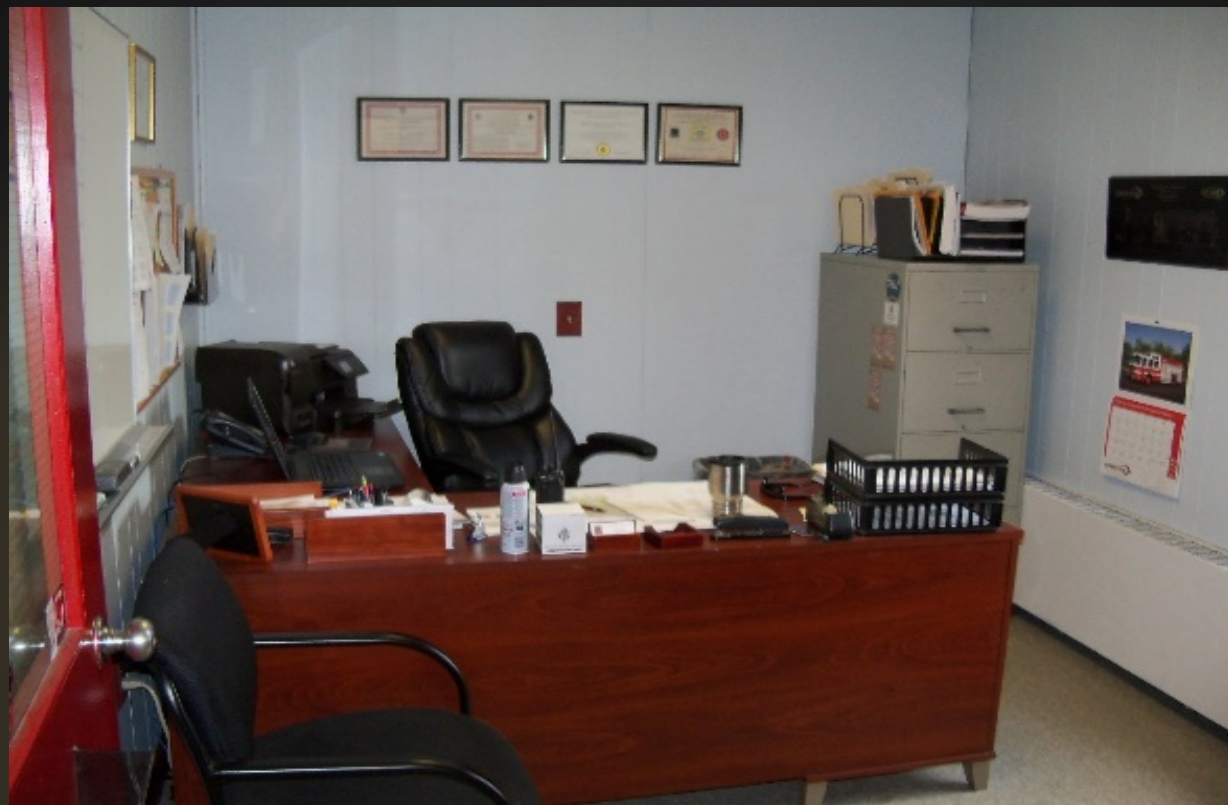
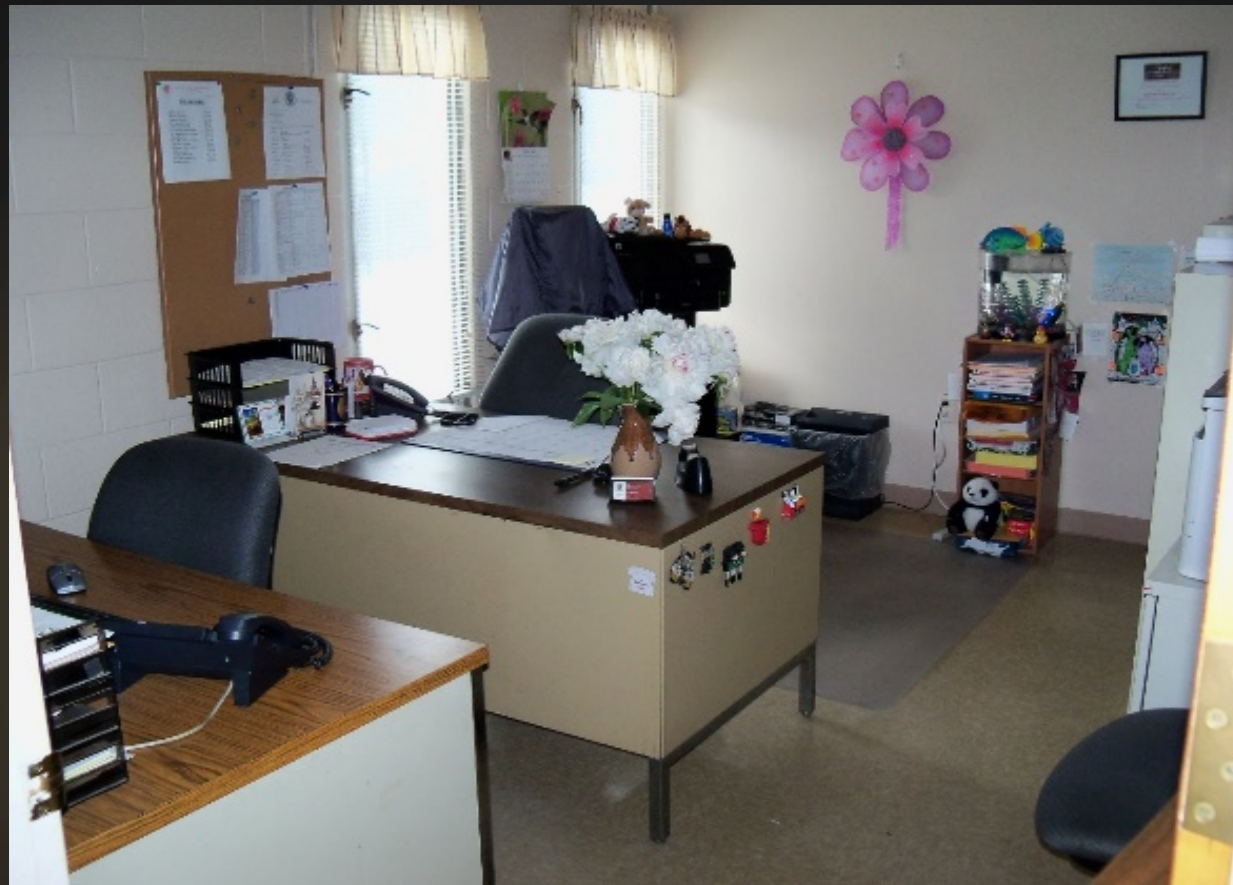
- ▶ The command staff and administration functions of the Department operate out of a total of 250 square feet of office space. The Fire Chief, Administrative Assistant, Fire Prevention, Training Division and Maintenance Division have to share this minimal amount of space. There is only one desk for the three divisions and the Deputy / Assistant Chiefs to work out of. When you add the file cabinets and office machines the space shrinks even more. The Chiefs and firefighters assigned to these divisions have to schedule around each other or are forced to work from home. To say the least this is counter productive. Customers that need to do business with the department stand in the doorway of the office while being served. A small table and chair are provided for filling out permits and forms. There is *zero security* realized by this configuration.

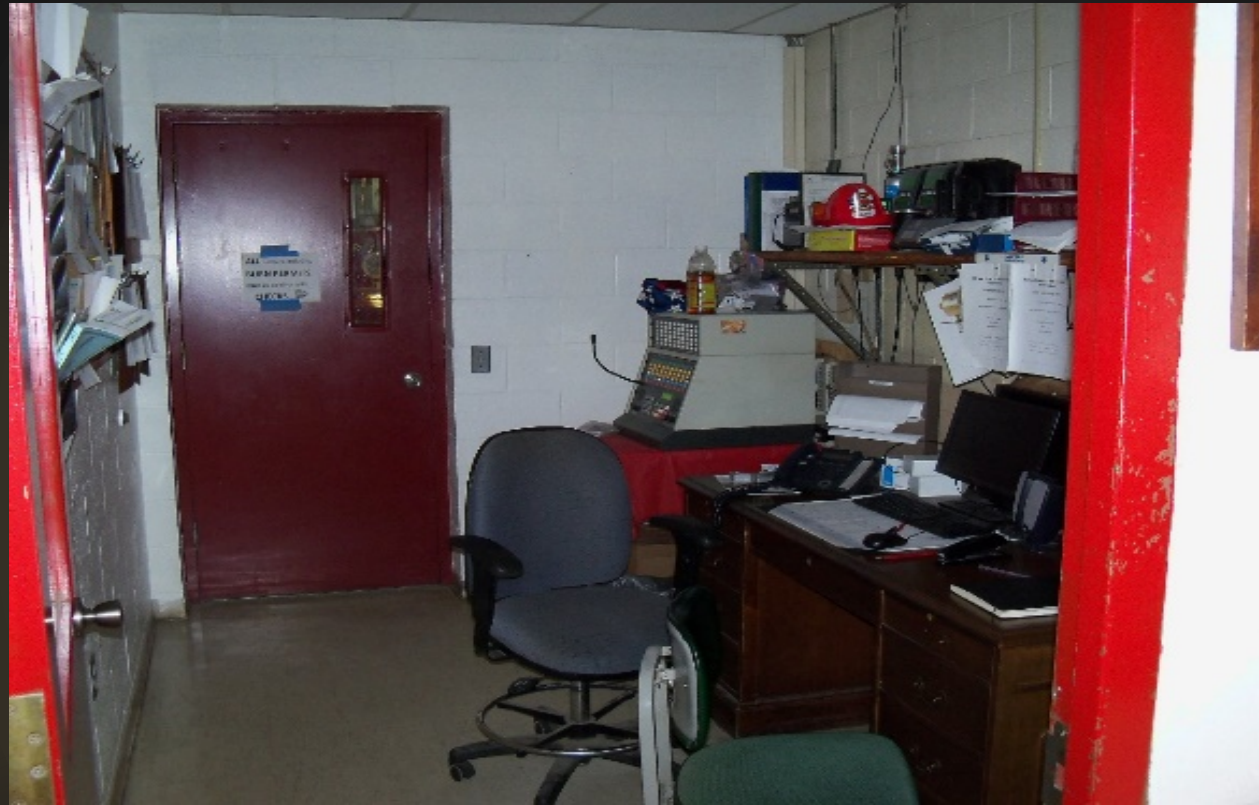
Station # 1

- ▶ The Station 1 officers and firefighters operate out of one 108 square foot “radio room”. The back up console for public safety dispatch is also located in the space. Once you add the desk, PC, printer and file cabinets it’s basically a closet. Other issues this presents for the operation of the Companies located here will be addressed later.

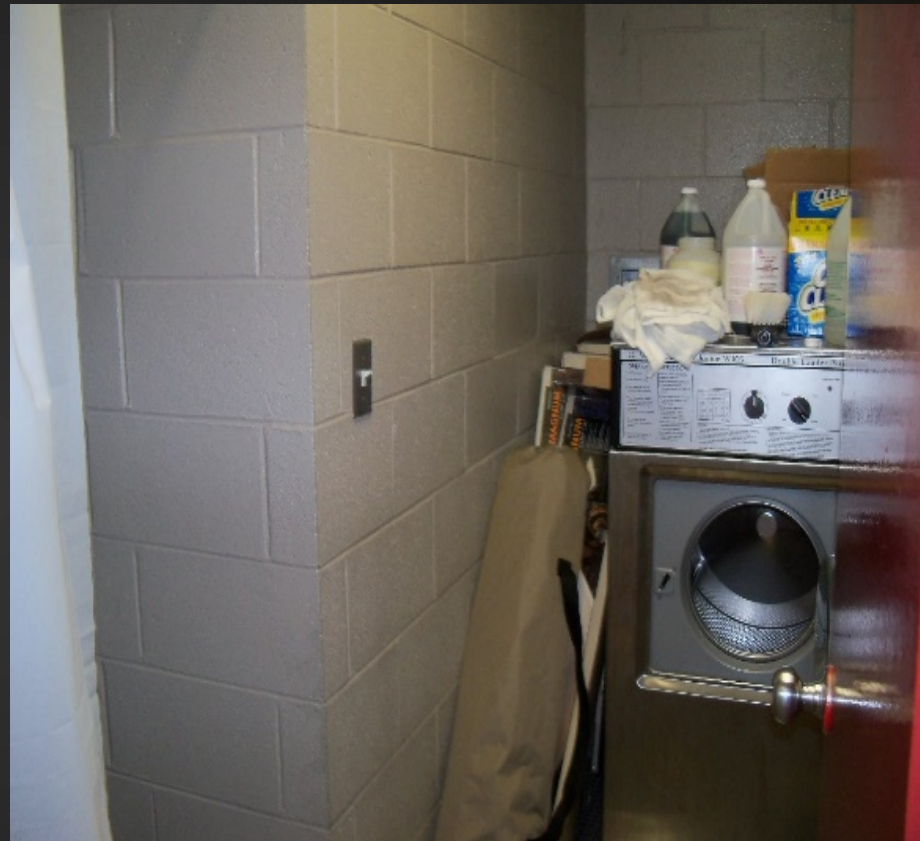
Decontamination room

- ▶ The decontamination room is 40 square feet. There is an emergency shower and turnout gear extractor located here. As with any other space in the building it has become a catch all for other items that need to be stored and is shared with the Rehoboth Ambulance. There is no space for a gear dryer which is desperately needed.

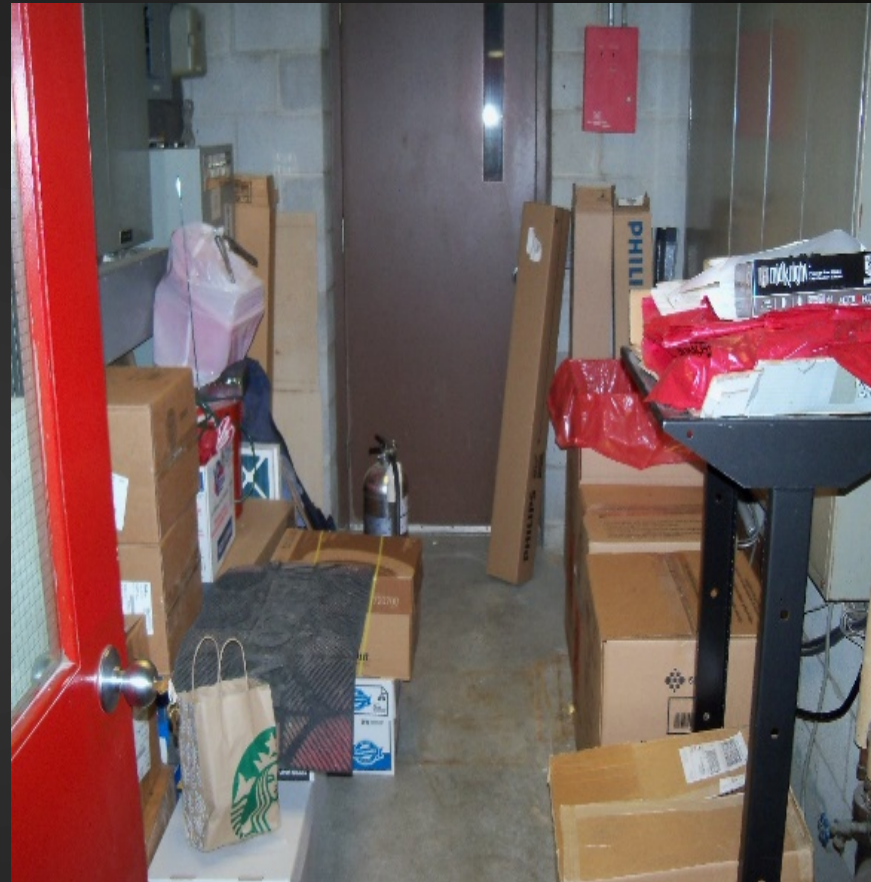
Storage

- ▶ The mechanical room for the facility doubles as the only storage space. About the best way to describe it is inadequate and unsafe. The items and supplies in the room have to be kept in a locked area. All of the 911 circuits, breaker panels, phone and internet systems are located here.
