REHOBOTH FIRE DEPARTMENT HEADQUARTERS SECTION &
COMPANY 1 QUARTERS - PUBLIC SAFETY BUILDING

OVERVIEW

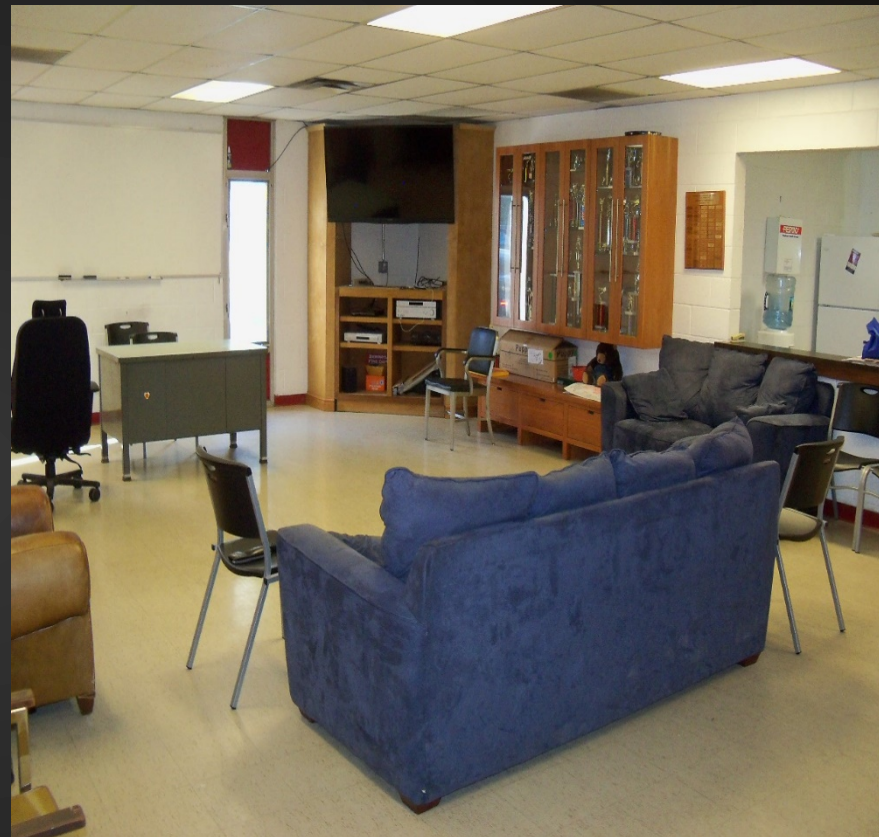
Common area

- ▶ The common area is shared by three agencies. The Ambulance duty crew is here from 7am to 5pm seven days a week. All of the furniture in the room has been donated by various agencies or purchased through grant money. The television was also donated. This area is also used for training, events, meetings and workshops. It is not conducive to any of these functions.

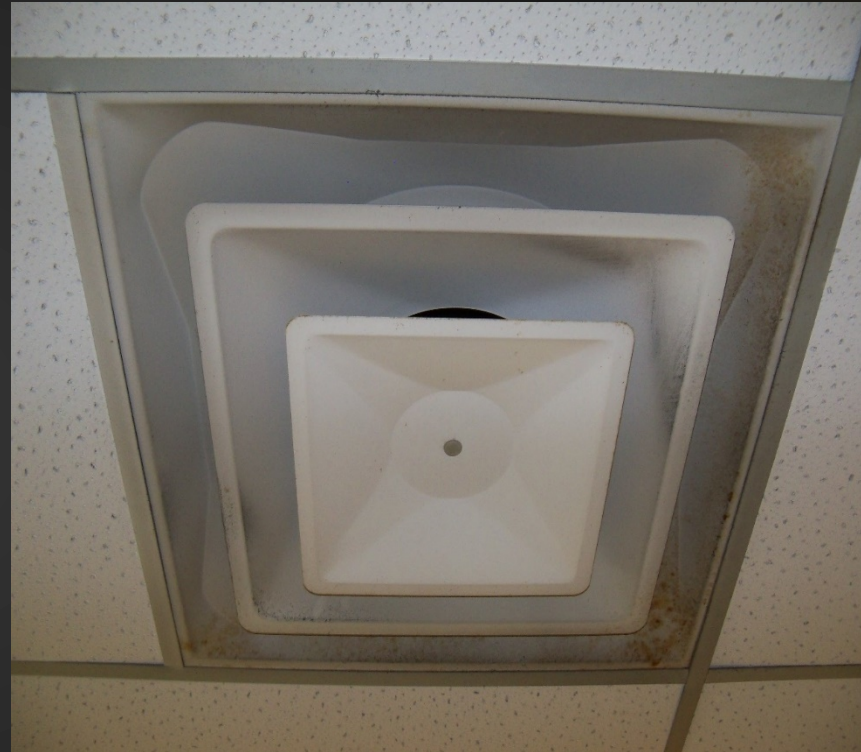
- ▶ The heating, ventilation and air conditioning systems in the facility are antiquated. When the Administration office, IT closet and Ambulance / REMA offices were added the HVAC system remained the same. Depending on the season, some areas are very cold or very hot. The exhausts and air intakes are no longer in the correct locations for the system to produce any kind of true climate control.

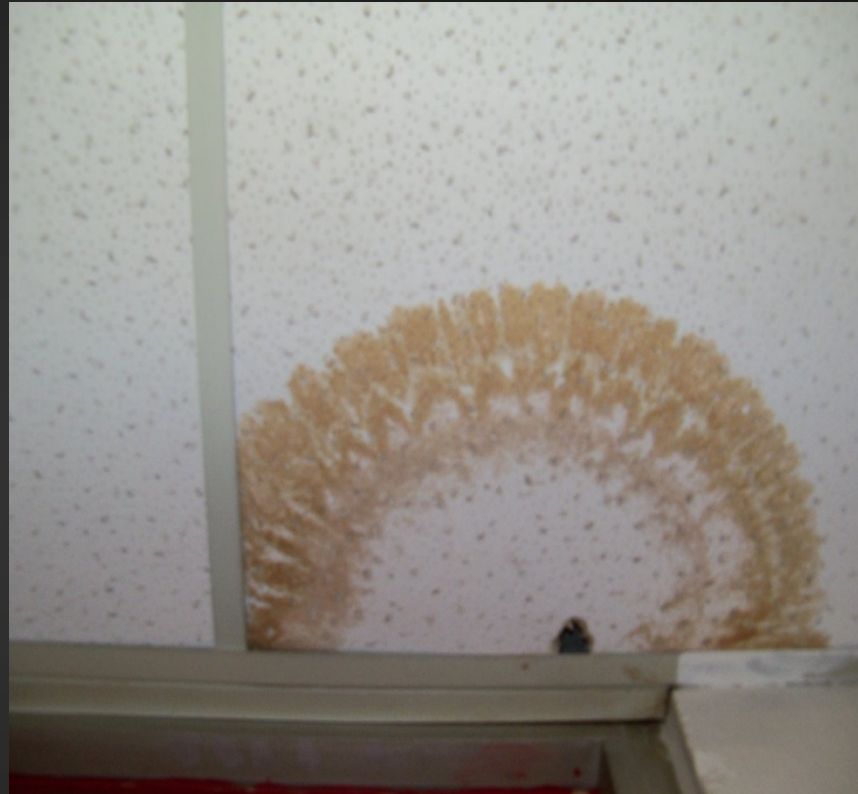
Roof

- ▶ The roof over the entire building not just the Fire Department spaces has been leaking for years. Boat loads of money have been spent patching, replacing and repairing the roof. This again is a result of poor original design. Ice and snow seem to cause the most problems. In the past, firefighters and police officers have had to go up on the roof to shovel off snow or break up ice. This practice was ended years ago due to safety concerns. Ceiling tiles have come in and are replaced due to staining constantly.
