REHOBOTH FIRE DEPARTMENT HEADQUARTERS SECTION &
COMPANY 1 QUARTERS - PUBLIC SAFETY BUILDING

OVERVIEW

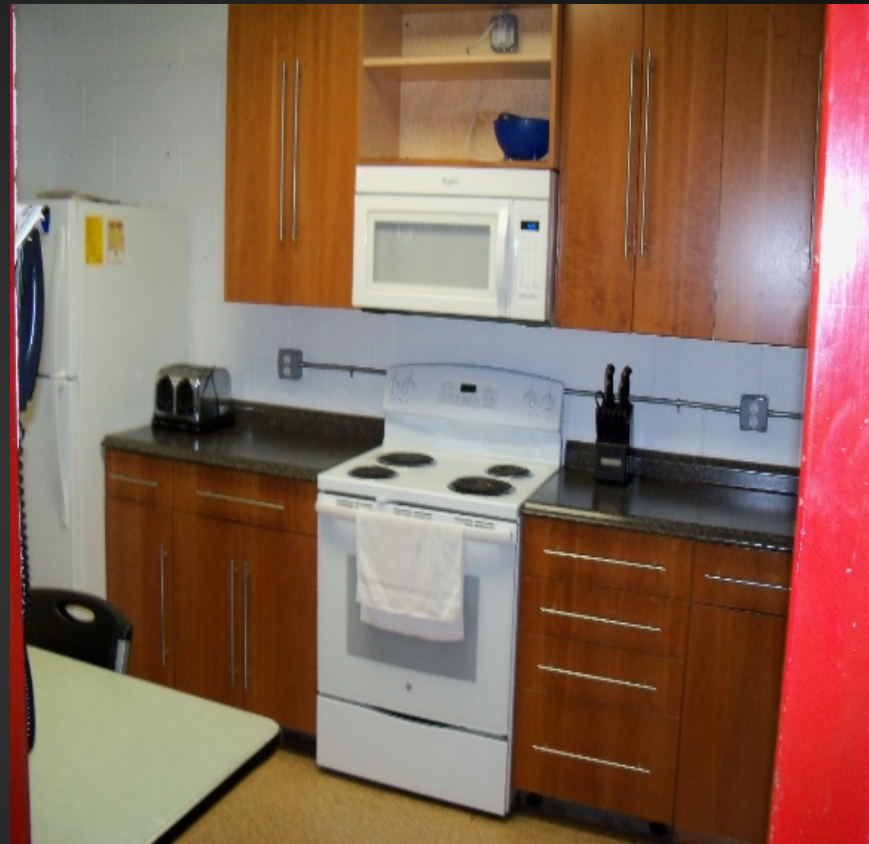
Kitchen area

- ▶ The small kitchen area is shared by three agencies. The area was renovated last year. The cabinets were donated by a firefighters company and he installed them at no charge. The stove and microwave were donated by Rehoboth Ambulance and installed with free firefighter labor. The area was painted by firefighters who volunteered their time. The Department did provide the counter tops and sink for \$350.
